## Fort Campbell Childers House

Historic Maintenance and Repair Manual

September 2006

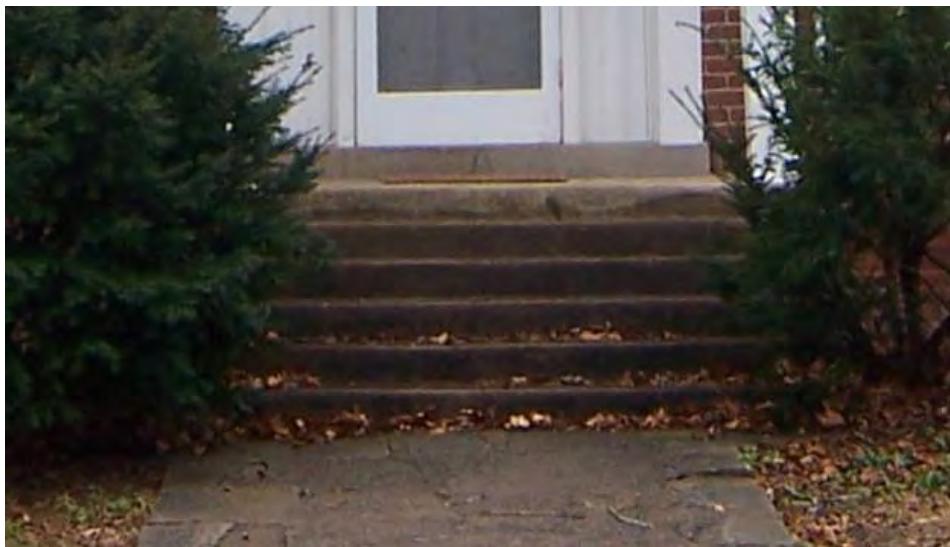
Figure 63. Front steps.

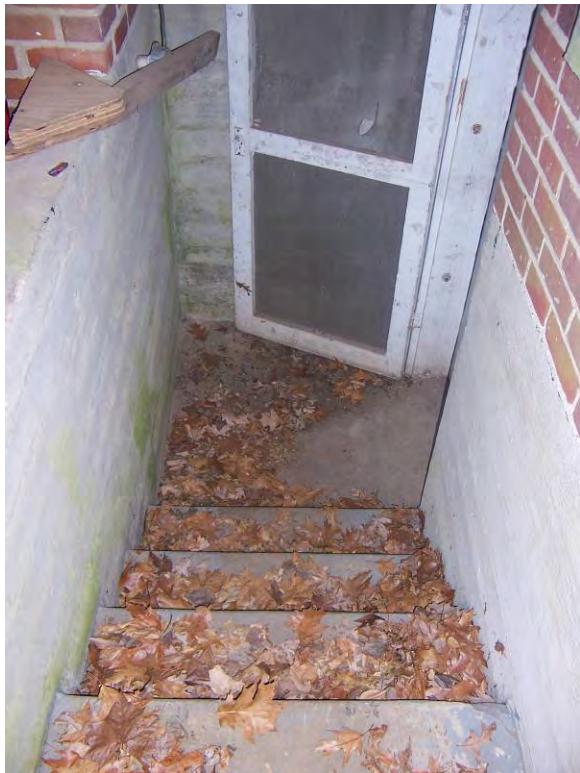
Figure 64. Steps down to basement from back patio.

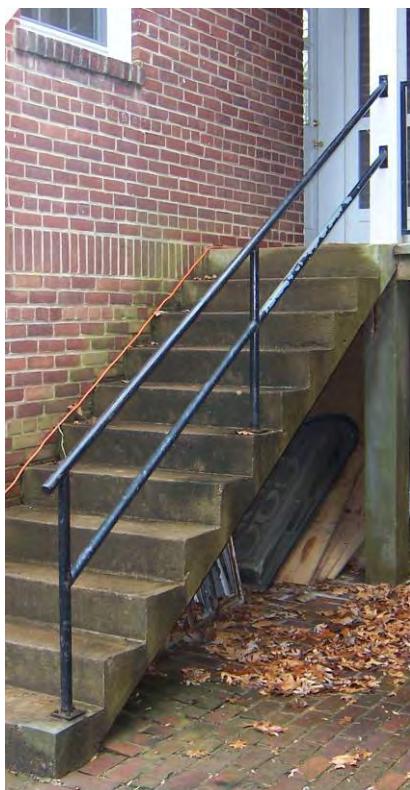
Figure 65. Steps up to kitchen entrance.

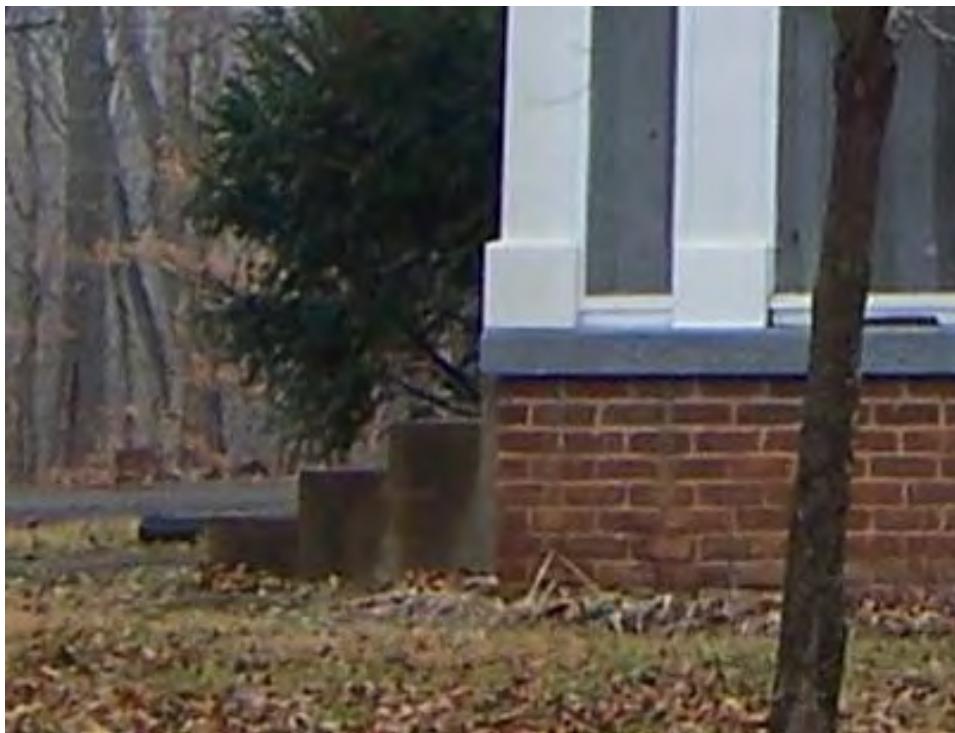
Figure 66. Steps up to side screened porch.

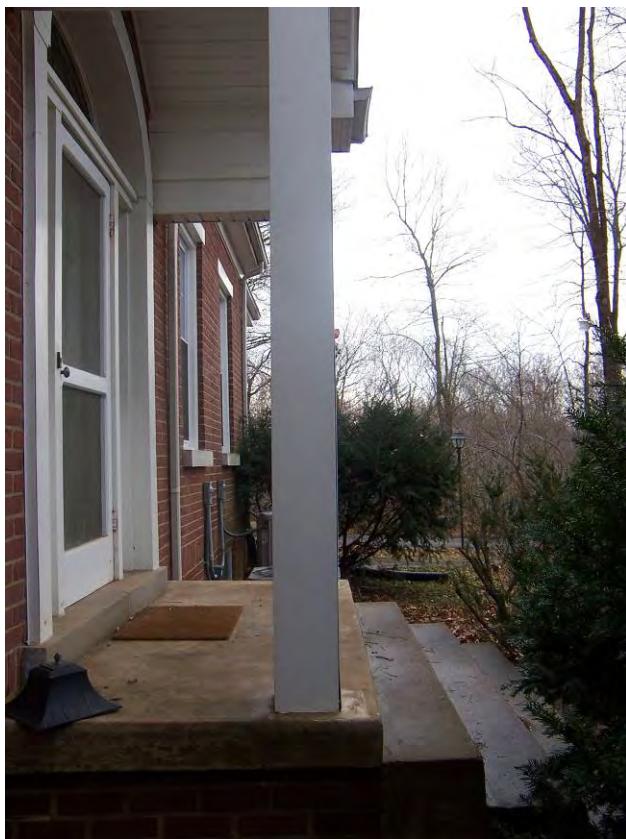
Figure 67. View of front stoop.

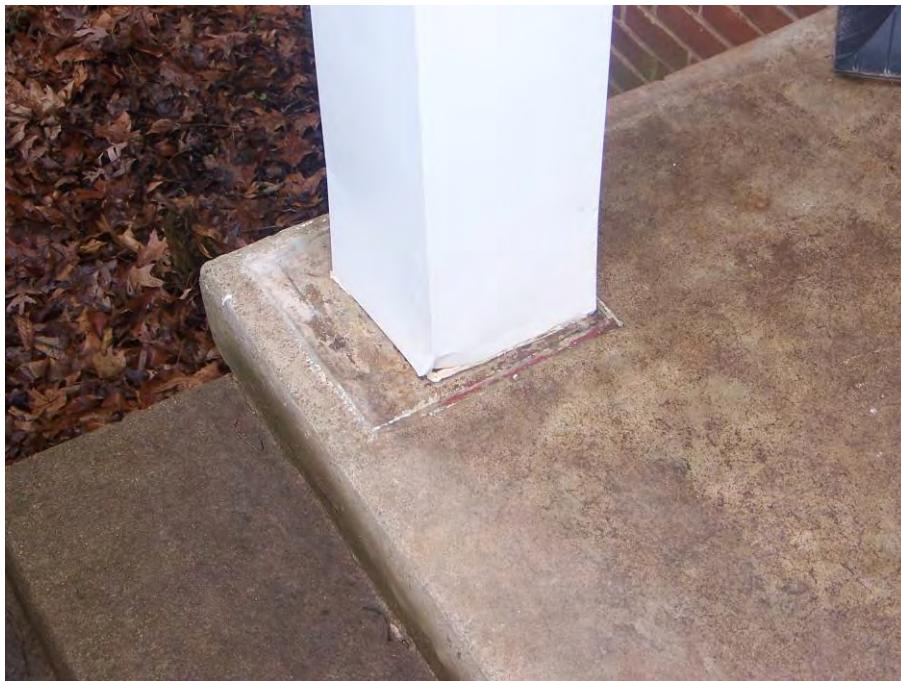
Figure 68. Closeup of northwest corner of front stoop.

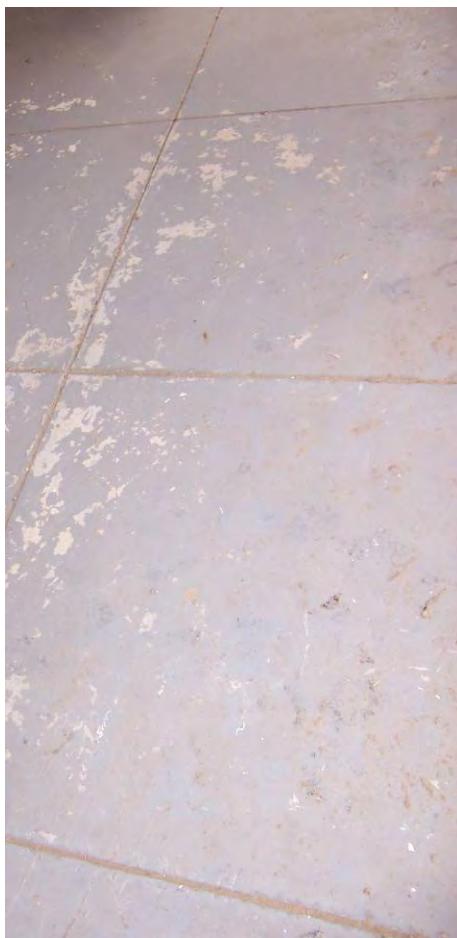
Figure 69. Flaking paint over concrete on screened side porch.

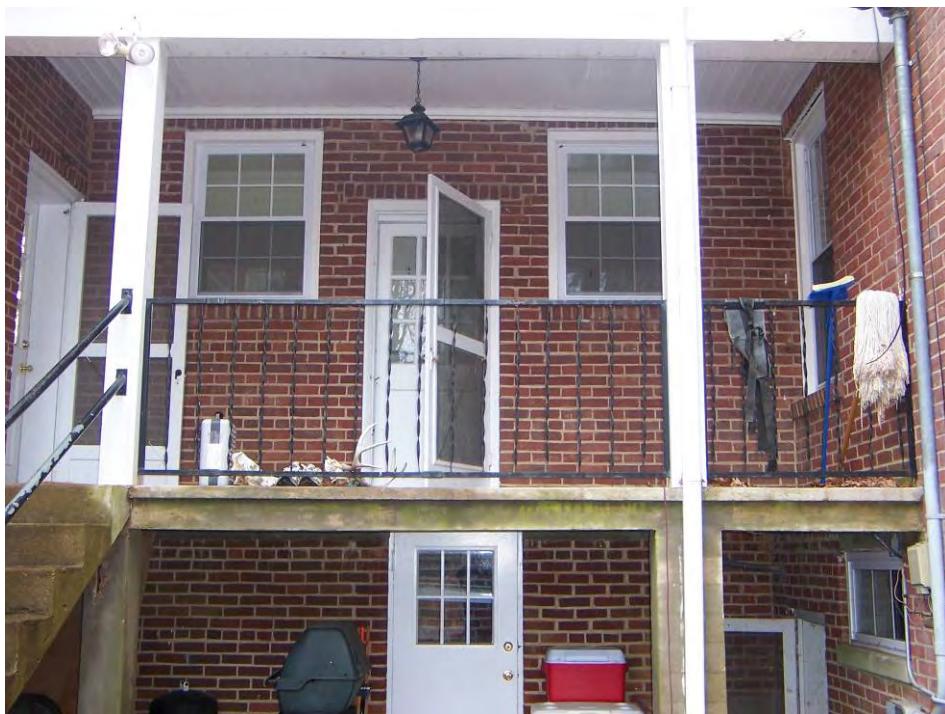
Figure 70. Concrete balcony.

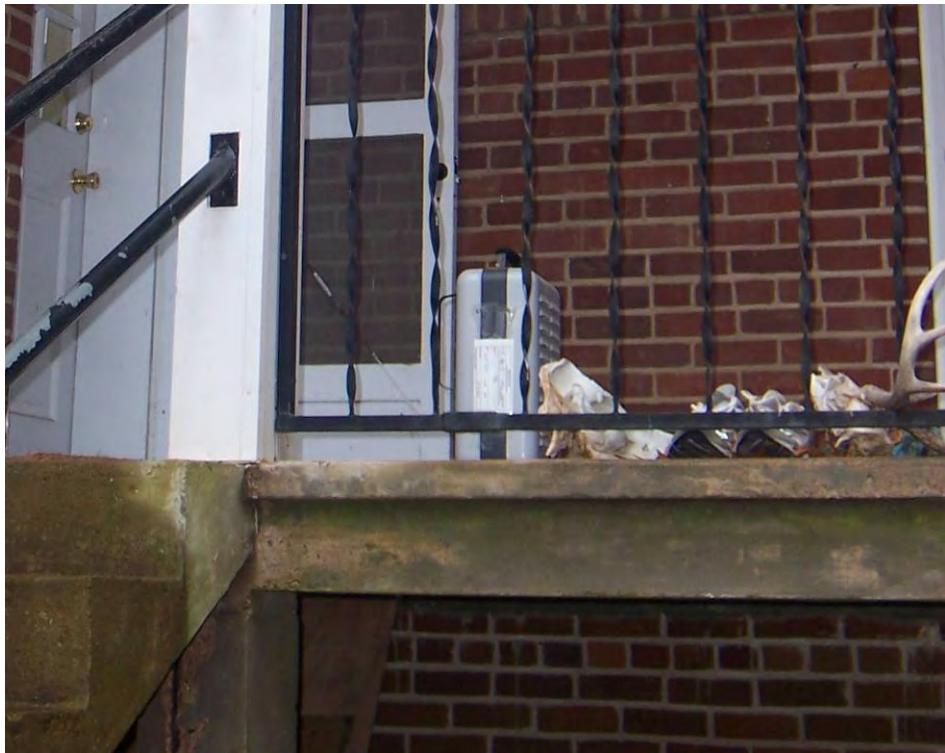
Figure 71. Closeup of concrete balcony.

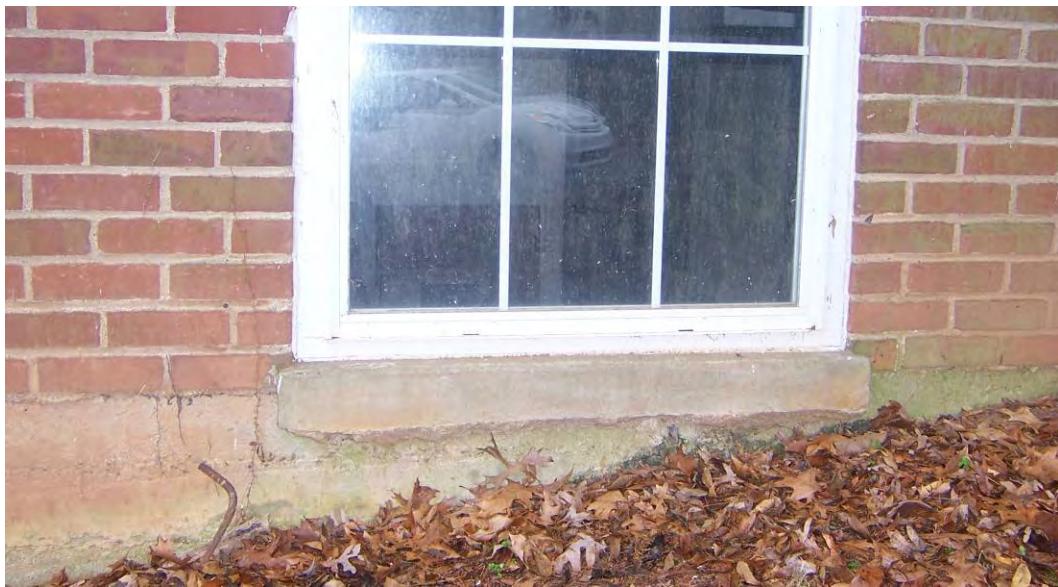
Figure 72. Stained concrete windowsill on basement.

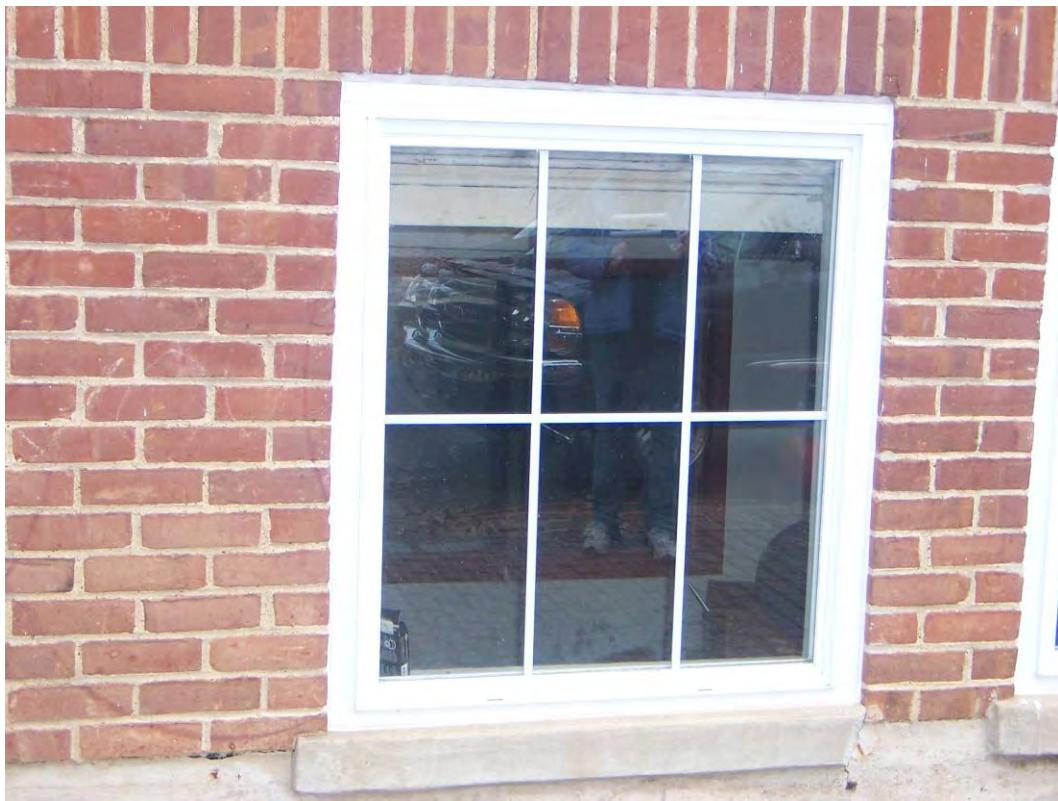
Figure 74. Concrete windowsill with a broken corner.

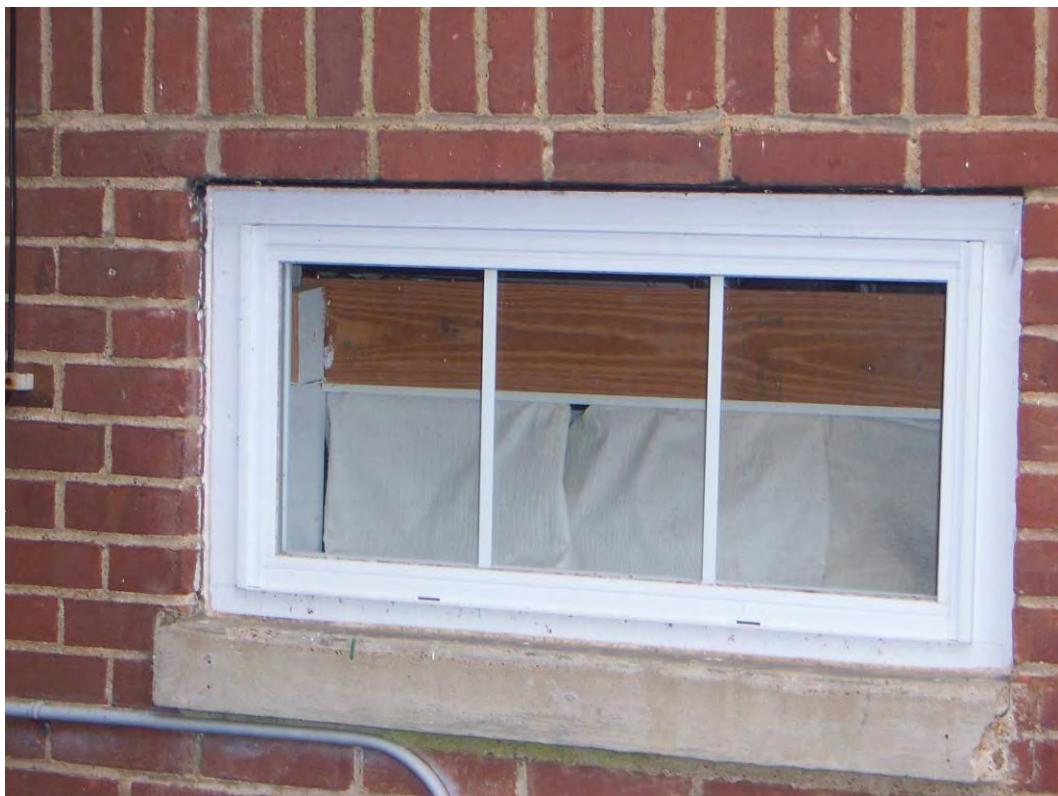
Figure 75. Concrete windowsill with a broken corner.

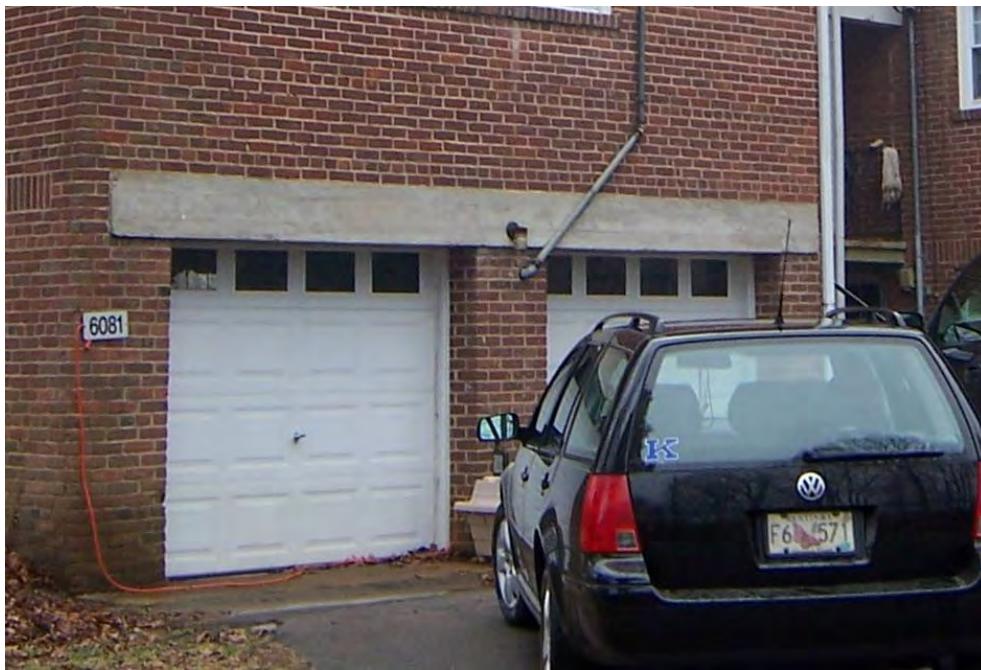
Figure 76. Concrete lintel over garage openings.

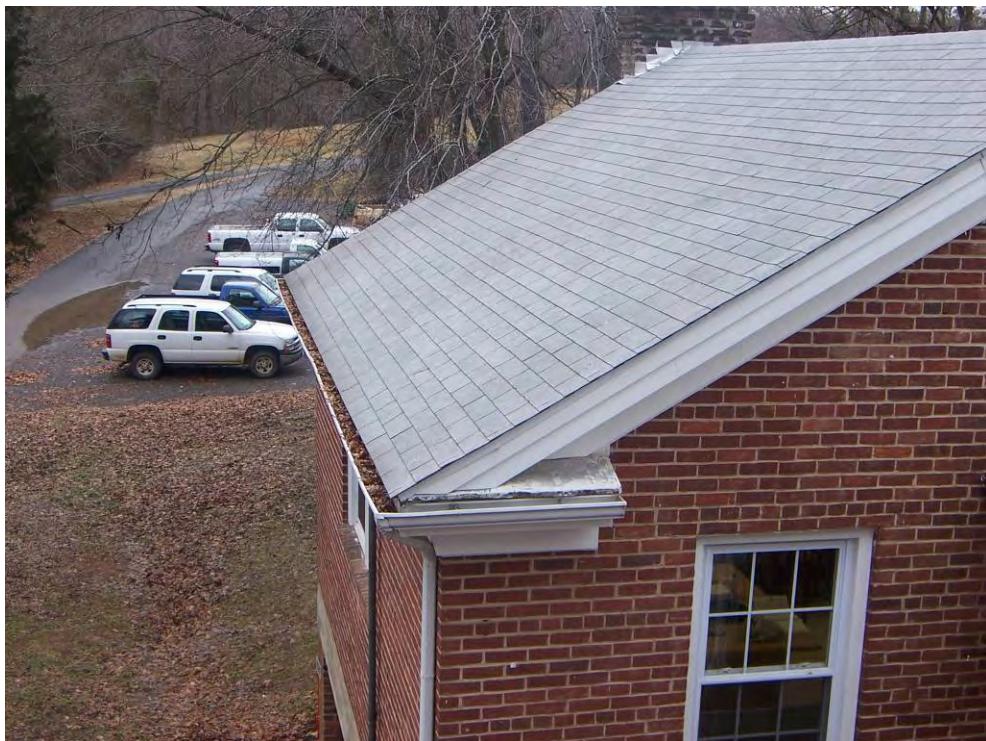
Figure 77. Three-tab asphalt shingles on kitchen addition.

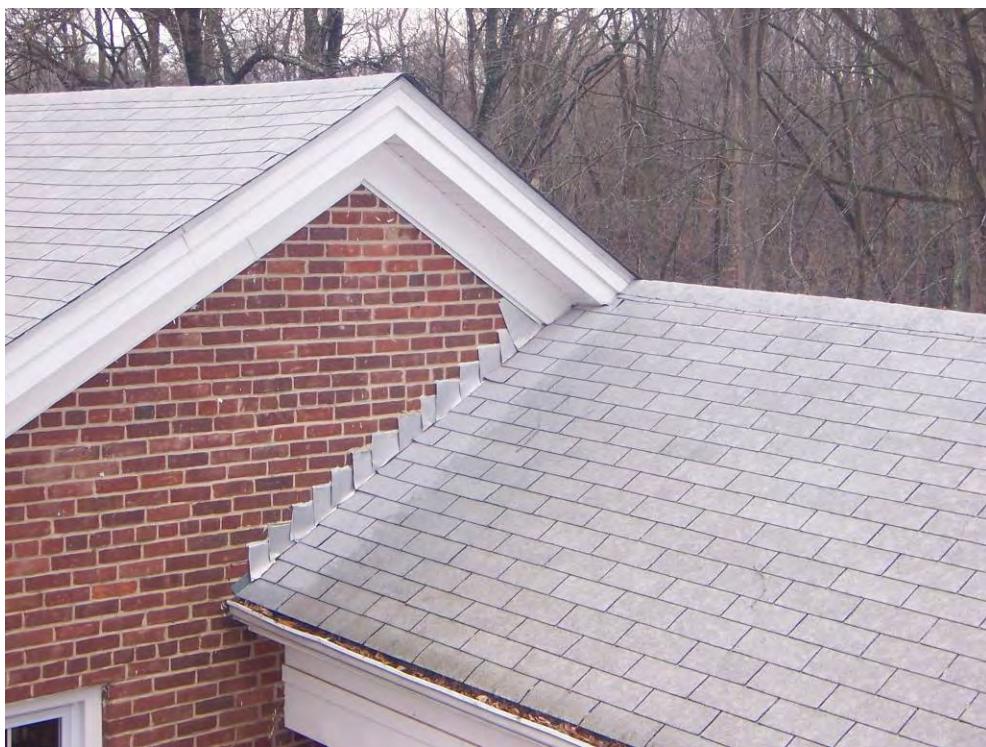
Figure 78. Three-tab asphalt shingles and metal flashing on hyphen between kitchen addition and main house.

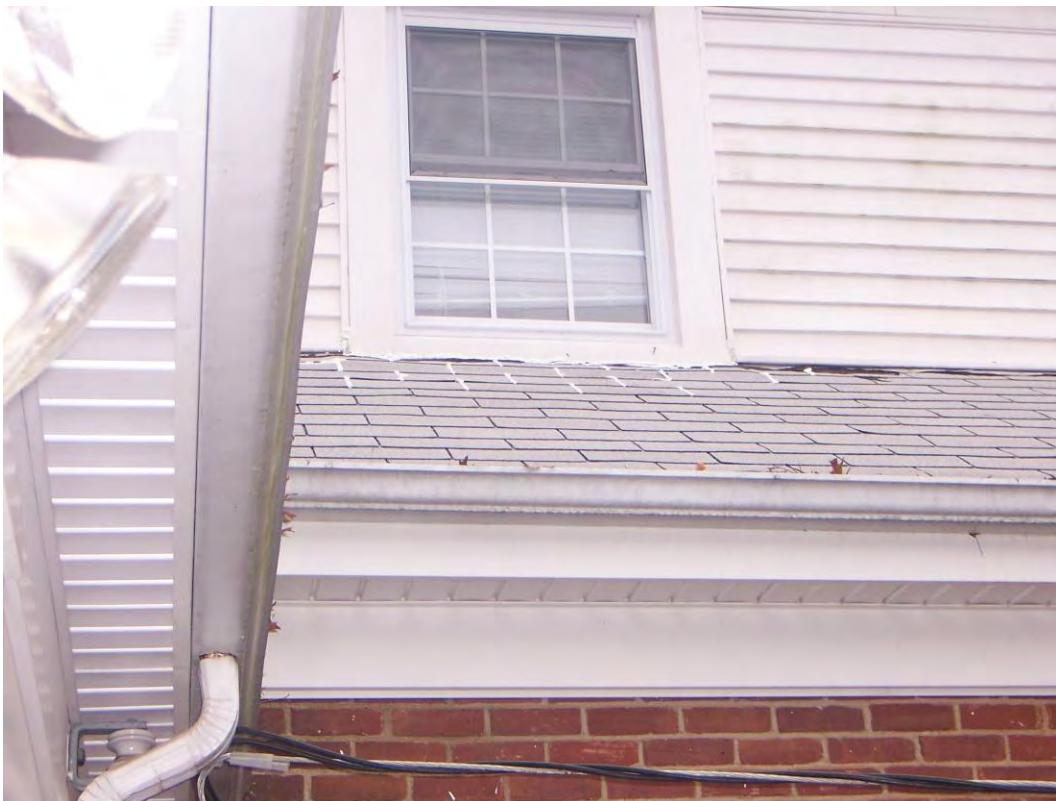
Figure 79. Three-tab asphalt shingles below rear shed dormer.

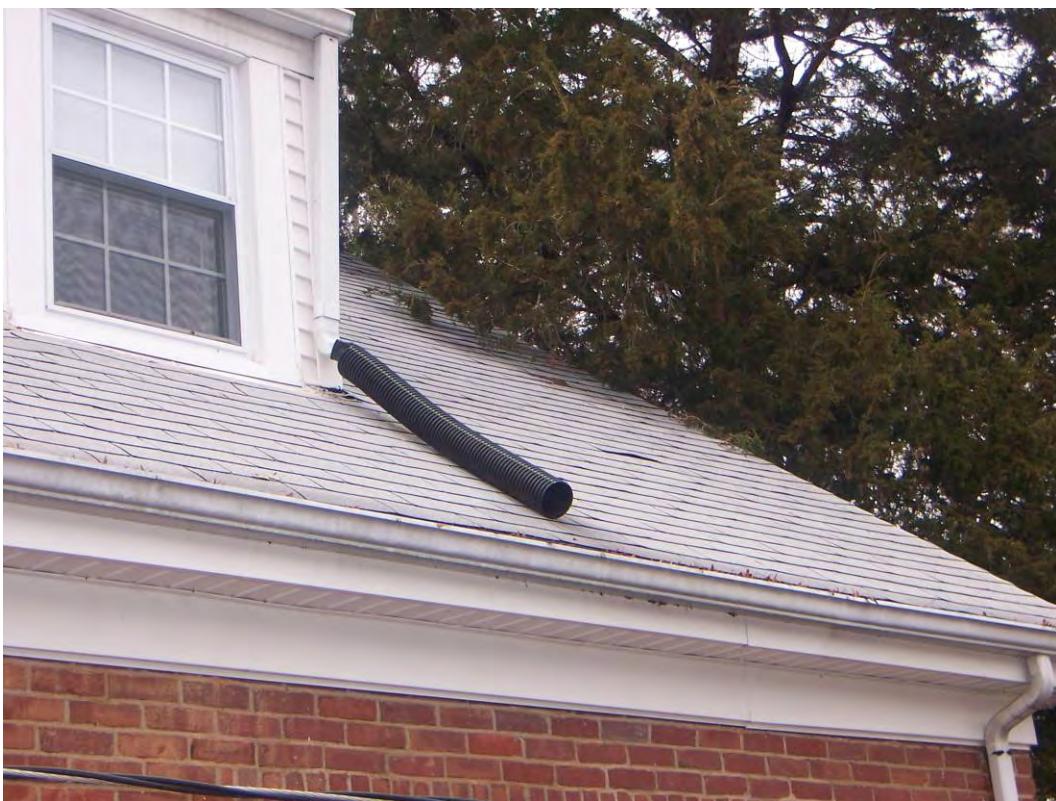
Figure 80. Three-tab asphalt shingles and plastic pipe that stops short of gutter.

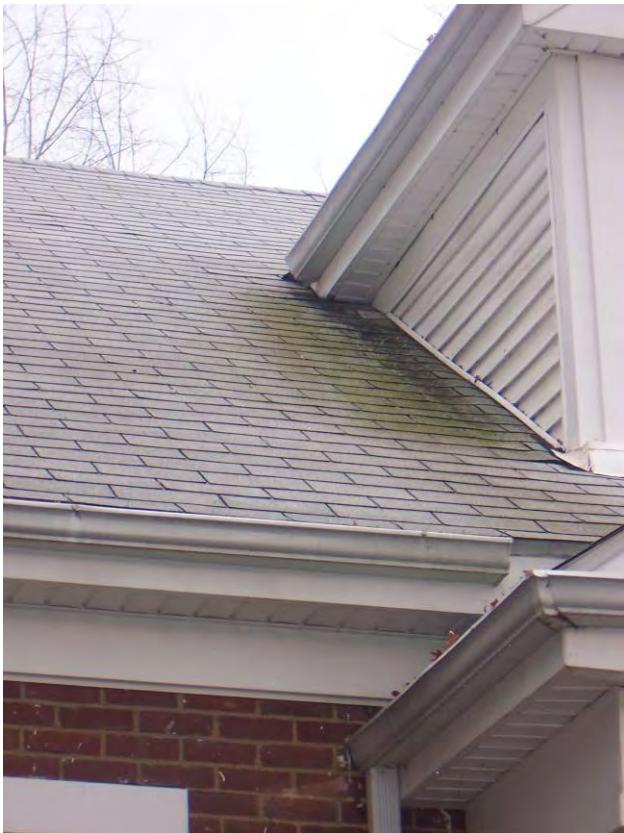
Figure 81. Lichen growth on front of roof near middle dormer.

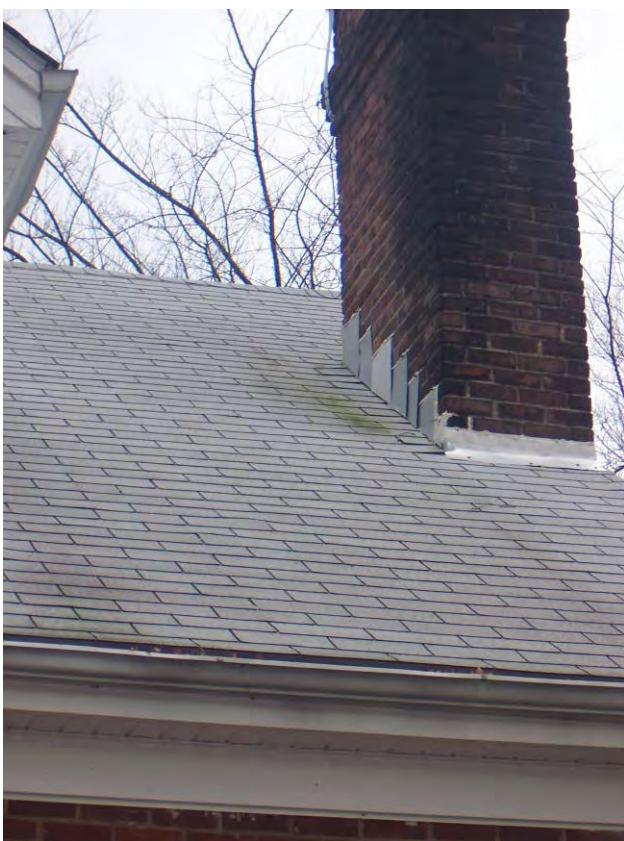
Figure 82. Lichen growth on north side of south chimney.

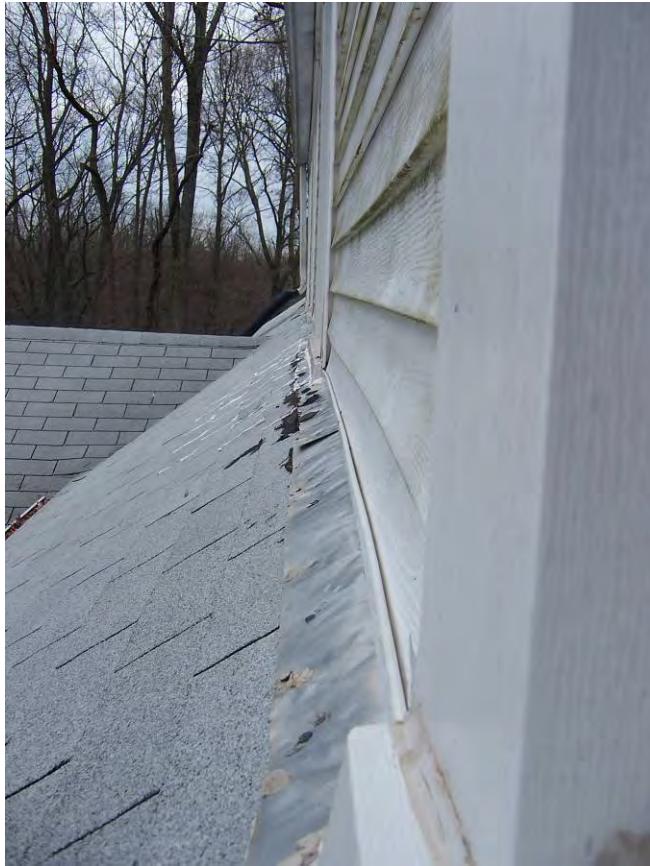
Figure 83. Flashing problems at base of rear shed dormer.

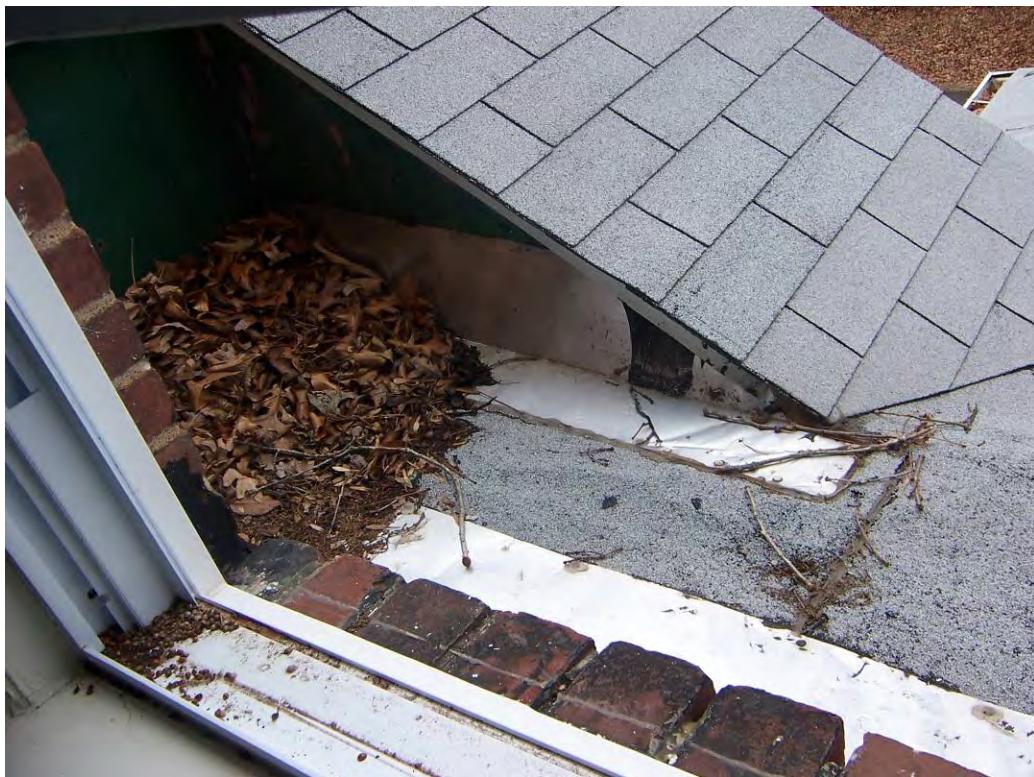
Figure 84. Fallen leaves that have not been removed in window well on south side of house.

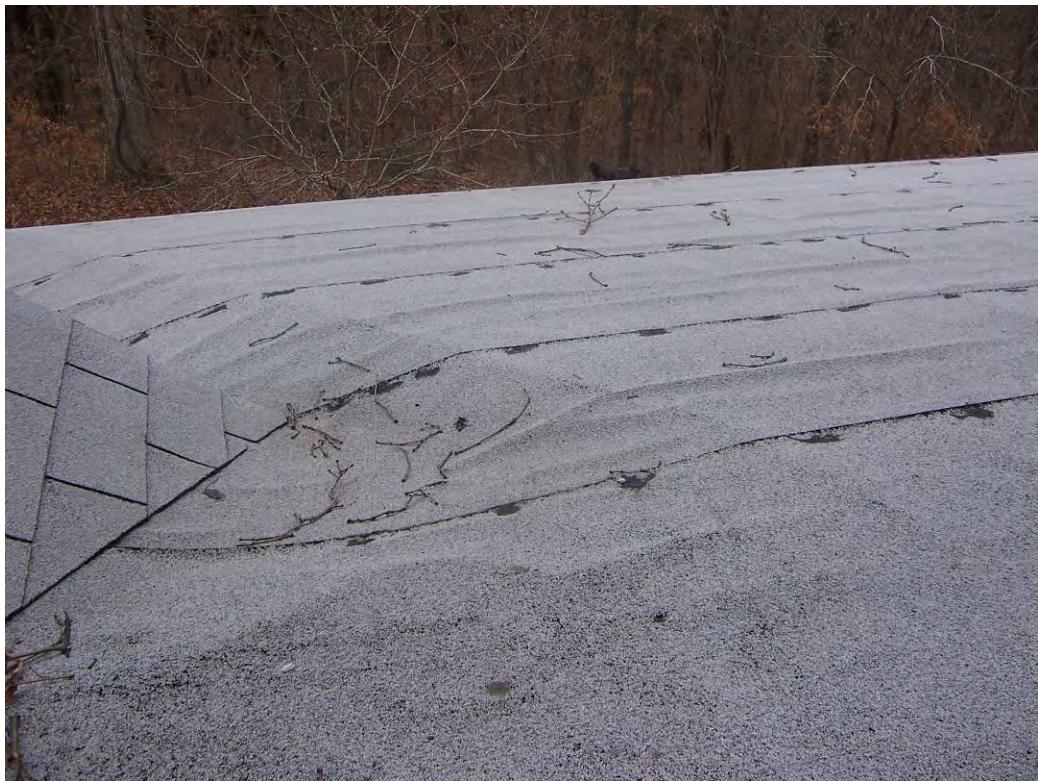
Figure 85. Incorrect connection between rolled asphalt roofing on screened porch and three-tab asphalt shingles.

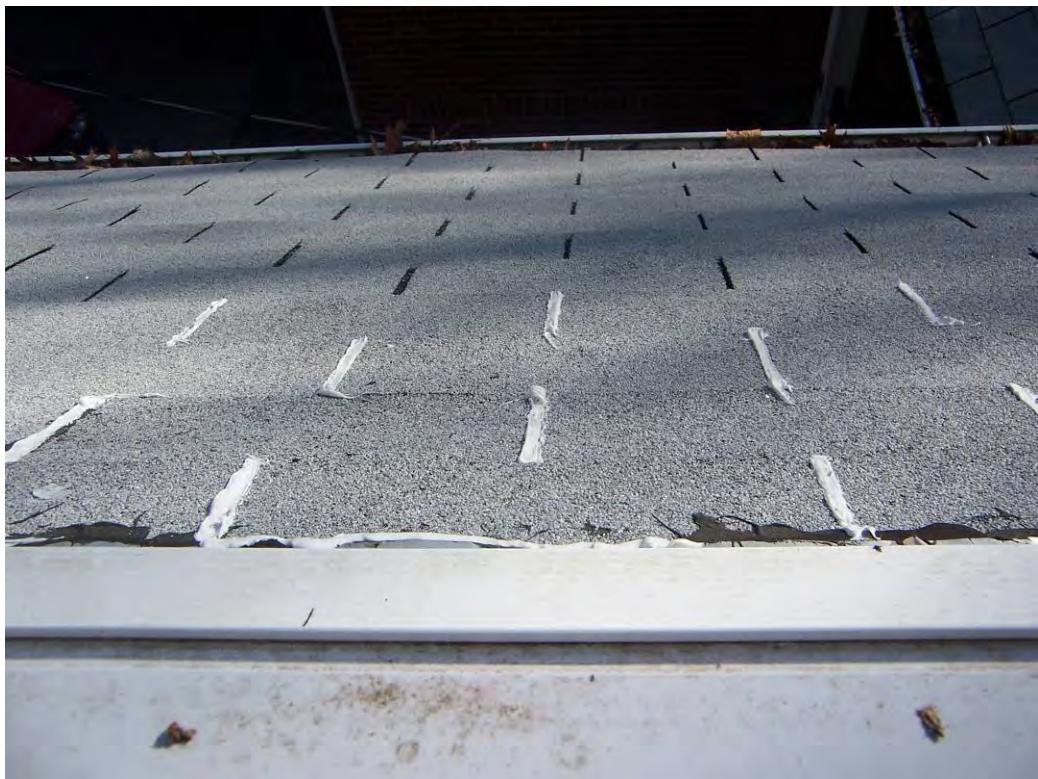
Figure 86. Use of caulk to patch three-tab asphalt shingles below rear shed dormer.

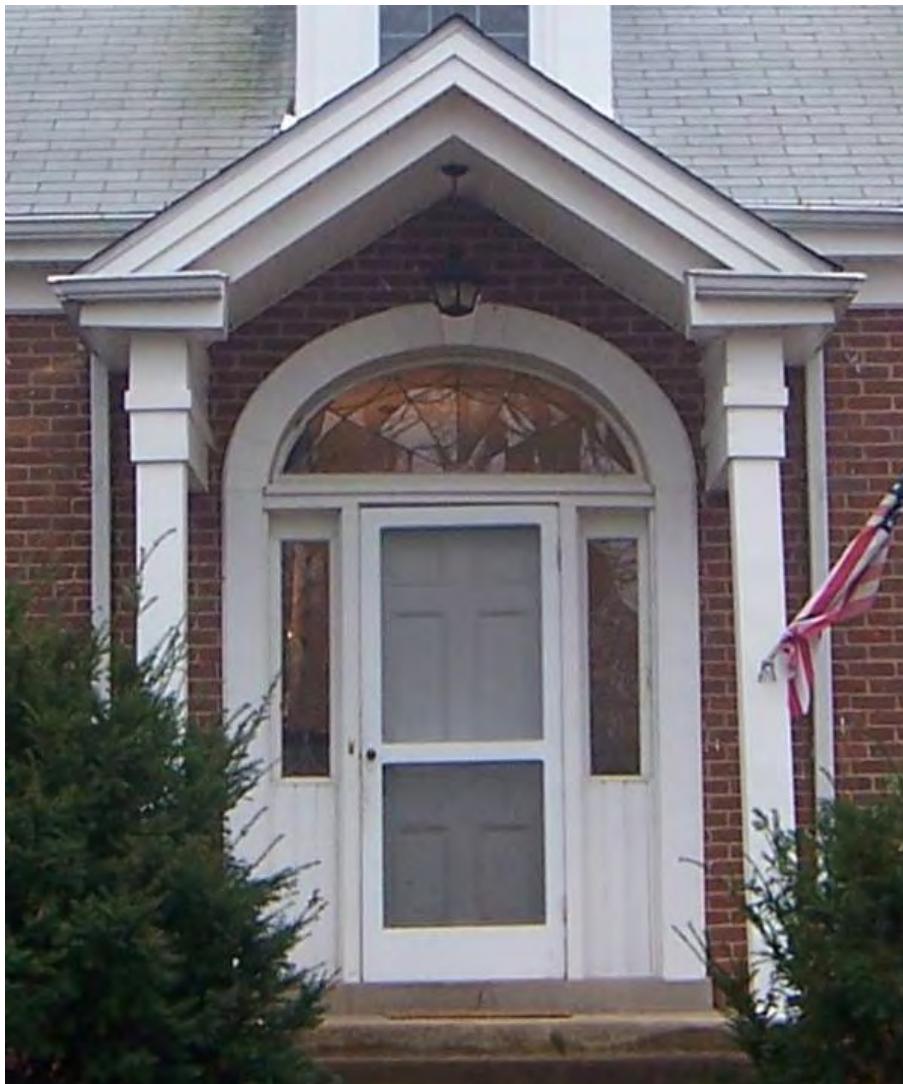
Figure 87. Wood screen door.

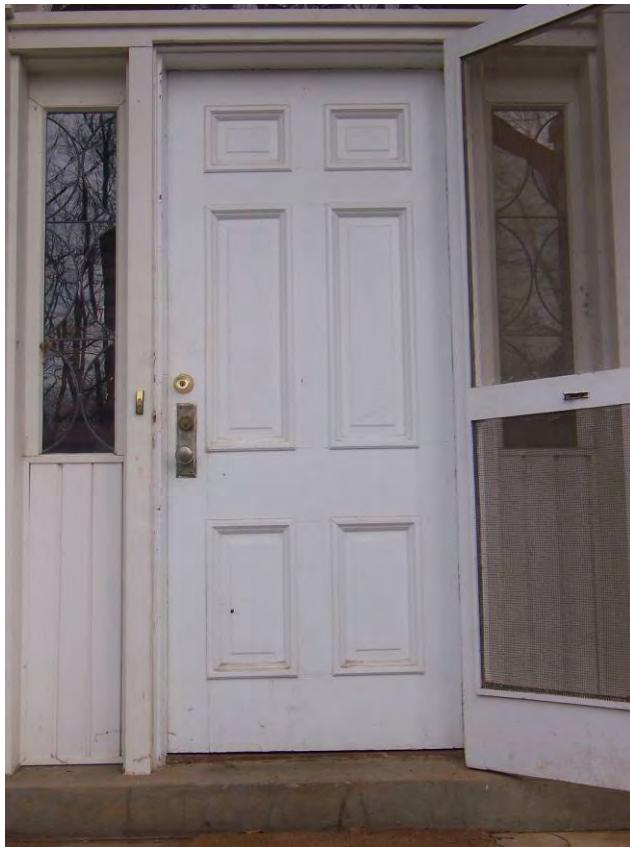
Figure 88. Outside of wood front door.

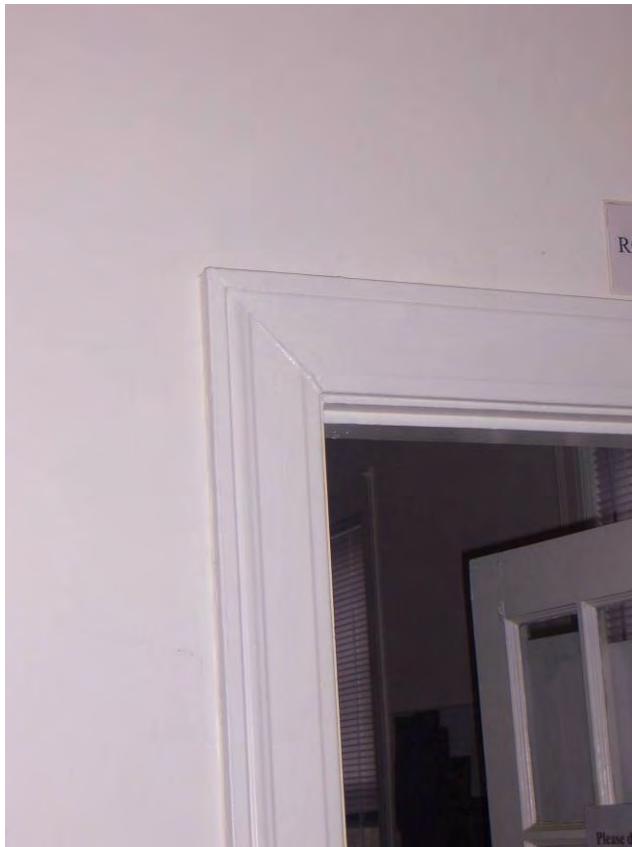
Figure 90. Interior wood trim.

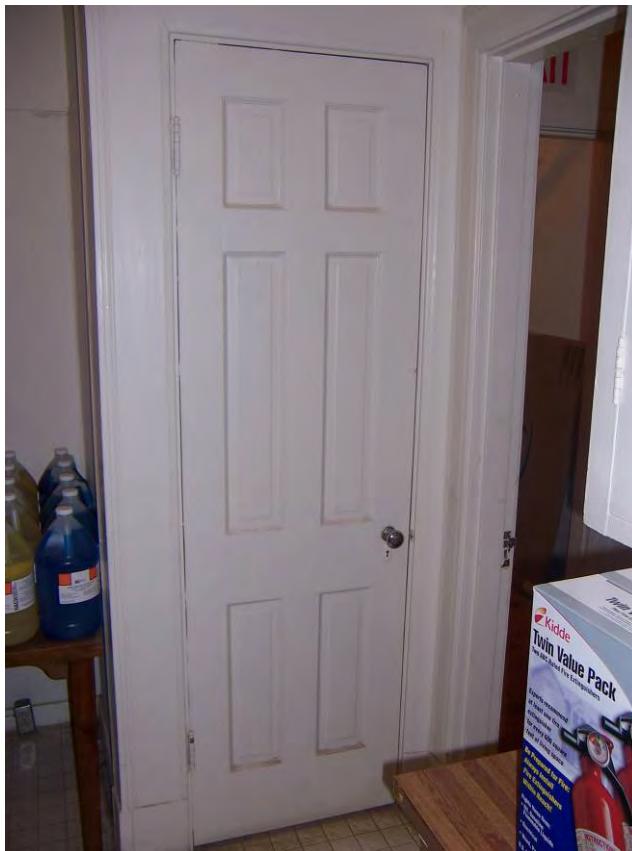
Figure 91. Painted inside wood door.

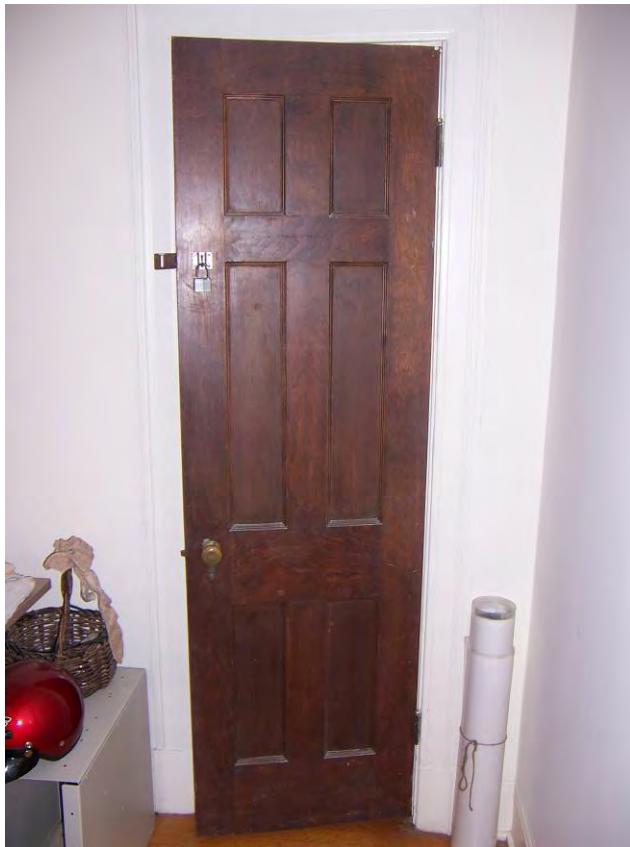
Figure 92. Stained closet door in northeast bedroom.

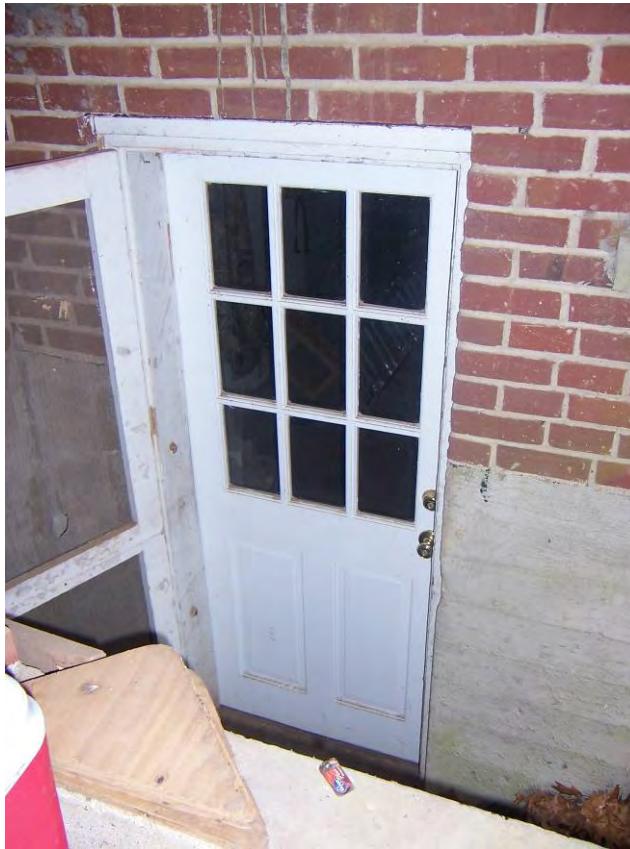
Figure 93. Wood basement door.

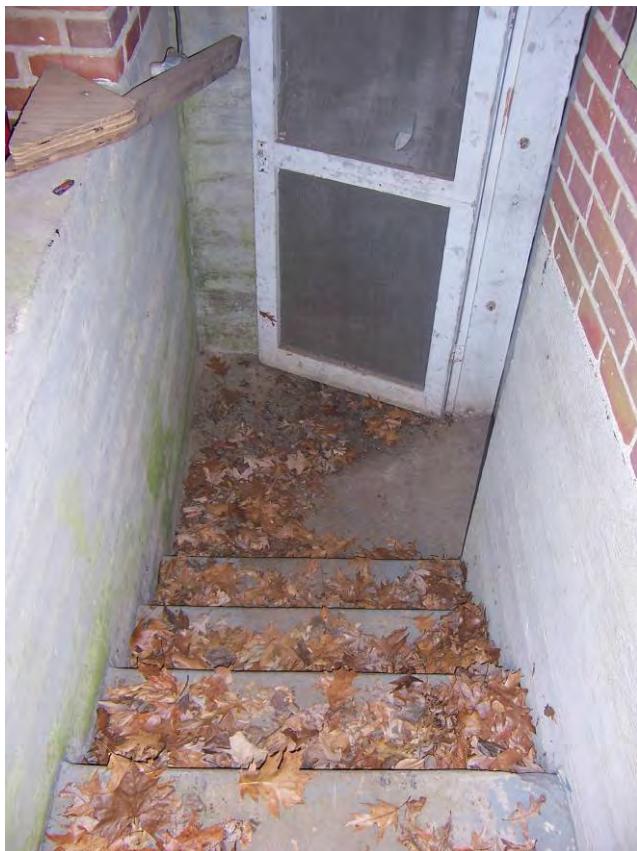
Figure 94. Wood screen door.

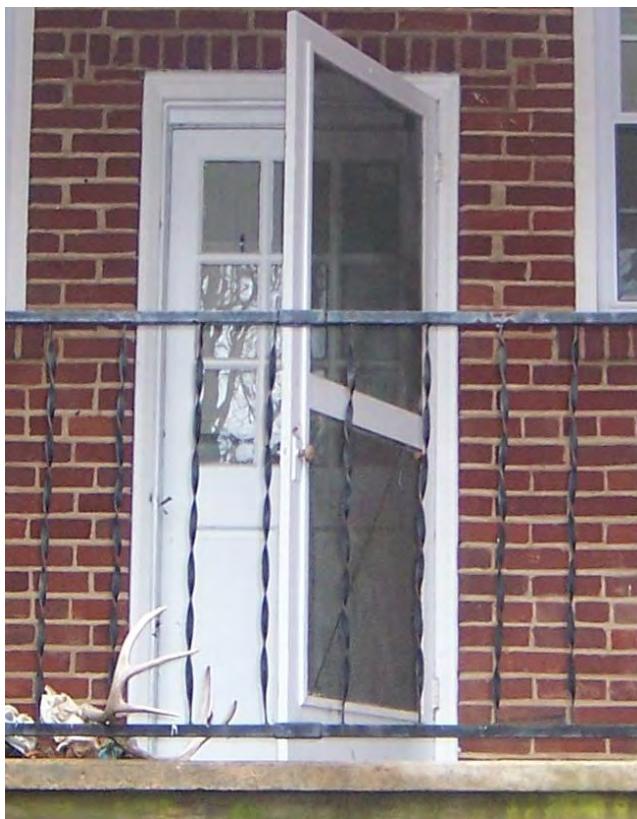
Figure 95. Wood screen door and entrance door to hyphen.

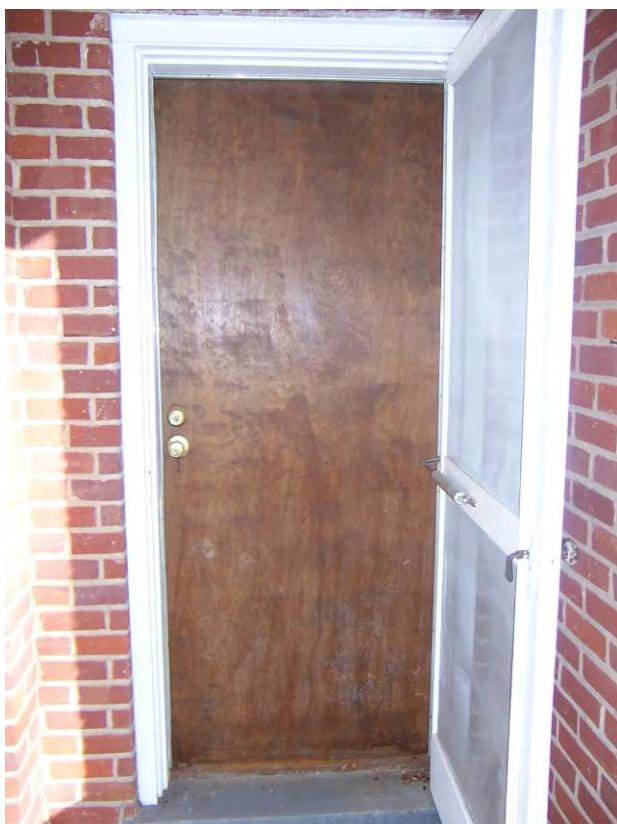
Figure 96. Replacement wood door from screened porch to living room.

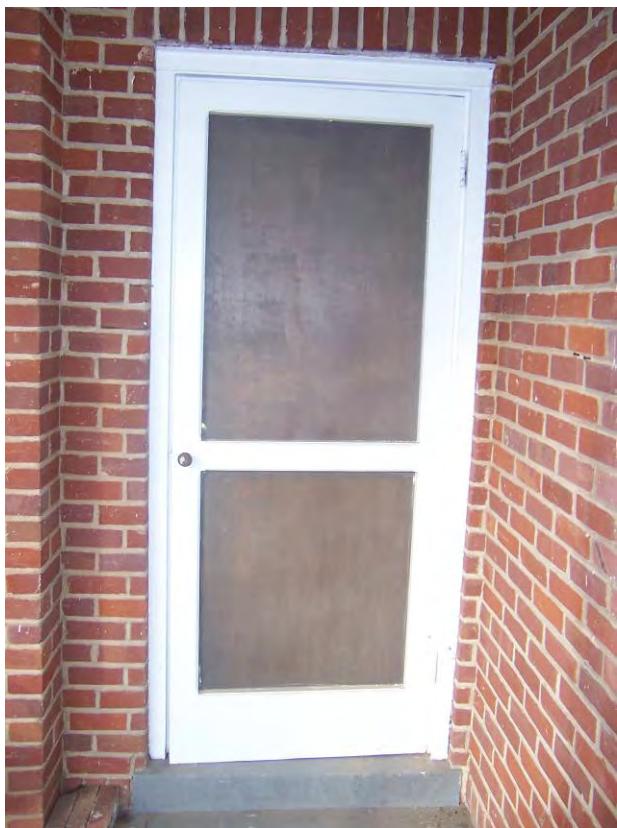
Figure 97. Wood screen door from screened porch to living room.

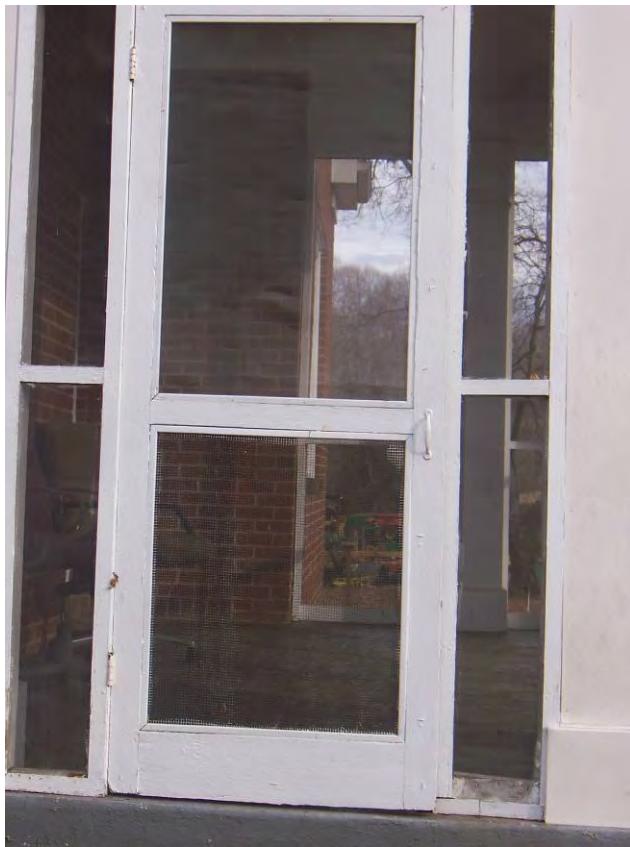
Figure 98. Wood screen door leading to screened porch.

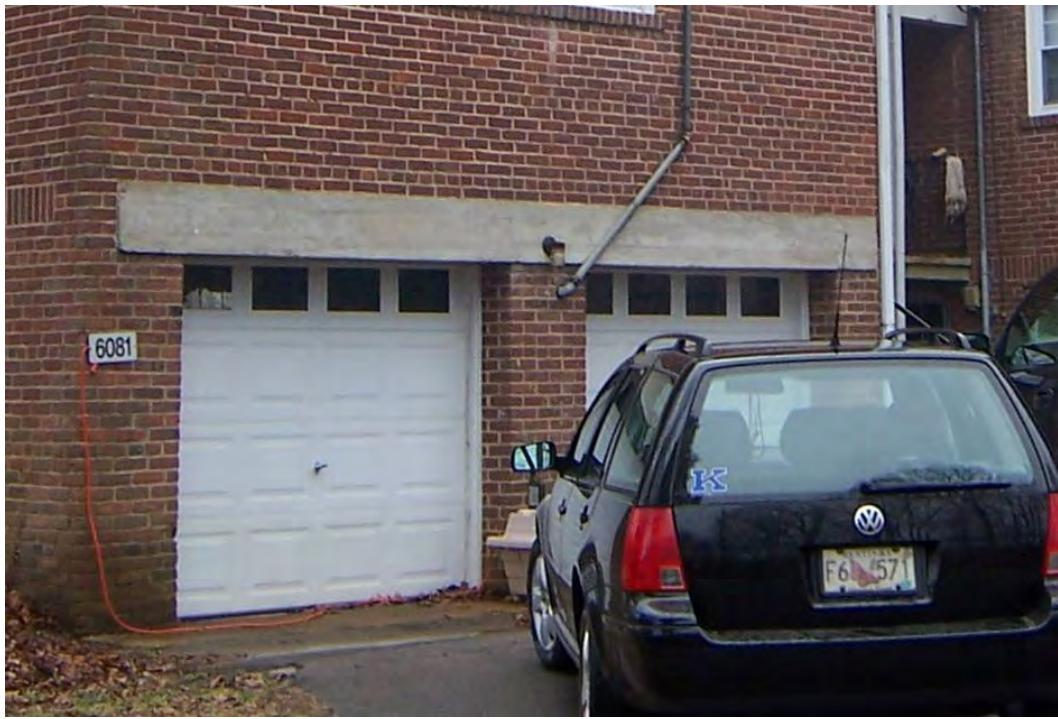
Figure 99. Replacement garage doors.
